For the Site of: The Graylings, Croydon, Surrey, CR3 7LN

Date: 02/09/2016

Emergence and Activity Bat Survey (EBS)

The following report details the findings and recommendations for the site of The Graylings, Croydon, Surrey, CR3 7LN.

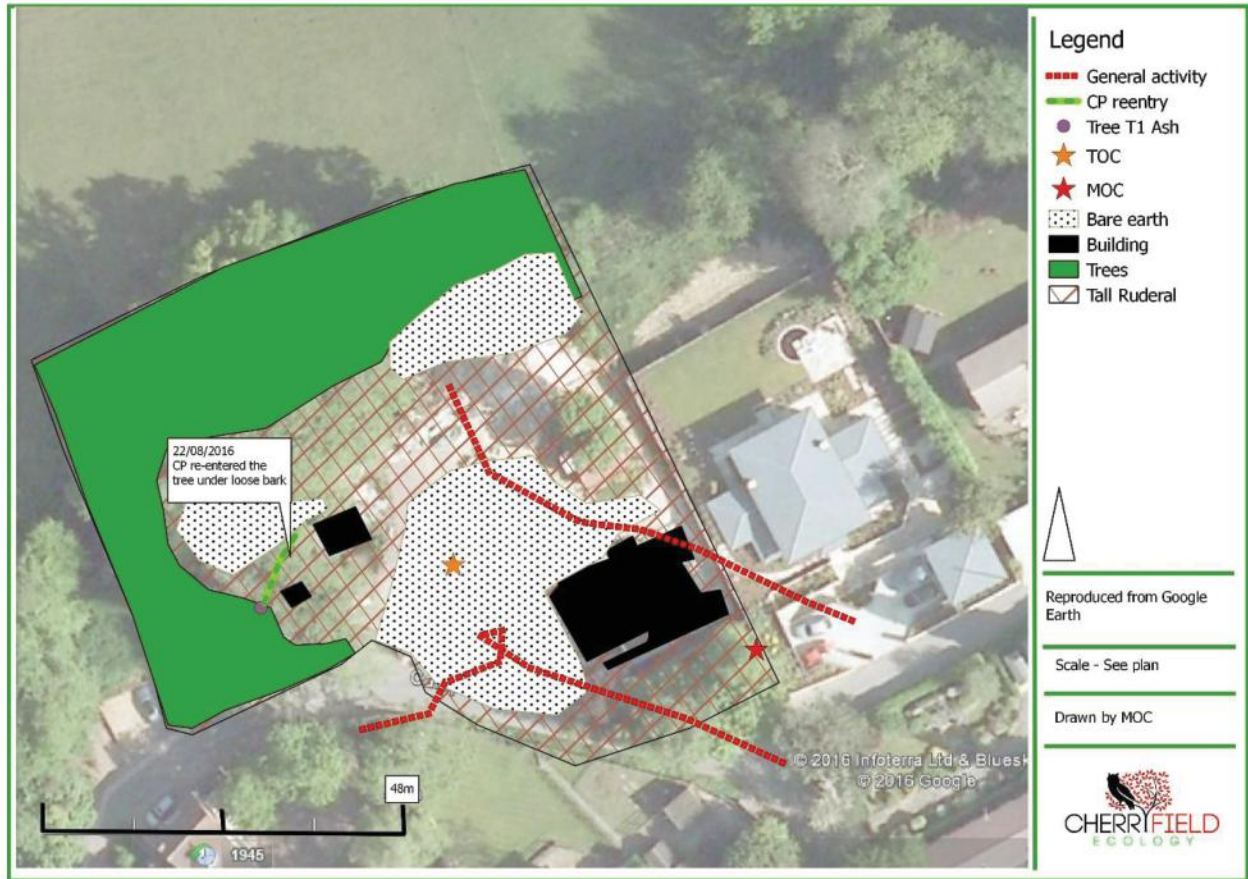
Figure 1: Site plan

Building/tree/structure reference - B1 and T1

Surveyor	Building, Tree or Structure	Dates and Times and survey type	Bat Activity Observed
Martin O'Connor (MOC)	B1	SS: 20.40 20.25 to 22.25 05/08/2016	Common pipistrelle (CP) <i>Pipistrellus pipistrellus</i> heard twice at 21.20 and 21.25. Brown long eared bat (BLEB) <i>Plecotus auritus</i> heard at 21.42.
Tanya O'Connor (TOC)	B1 and T1	As above	Single CP heard at 21.25
MOC	B1	22/08/2016 SR: 6.00 04.30 to 6.00	CP heard on three occasions passing through the site. BLEB was heard on two occasions at 5.15 and 5.22, but was not seen, although the internal areas of the building were checked.
TOC	B1 and T1	As above	CP heard feeding over the grounds and passing by. At 5.46 a CP was seen dawn swarming around the dead ash tree, it then landed on the tree several times before roosting under loose bark at 5.46.

The development will involve demolishing the currently partly built dwelling and replacing this with a new dwelling. A single dead ash tree is also located on site. No bats were found to be using the building, however a single common pipistrelle was found to be using loose bark on the dead ash.

No further surveys are considered necessary at this time (as the tree will be left *in situ*). Should the tree need to be felled at any point in the future at least one further survey will be required (if within 12 months of this survey) to meet national standards (three surveys) in order to apply for an EPS licence or if outside this period at least two surveys to update the results, one dusk and one dawn.
